**DHI**  
**DeRick Home Inspection**

HOME INSPECTION REPORT  
**Prepared Exclusively For:**

Inspected by Paul DeRick, Lic.#: 25735 on 10/23/2022  
Phone: (281)744-5036, Email: [derickhmins@outlook.com](mailto:derickhmins@outlook.com)  
Website: [www.derickhomeinspection.com](http://www.derickhomeinspection.com),

# PROPERTY INSPECTION REPORT FORM

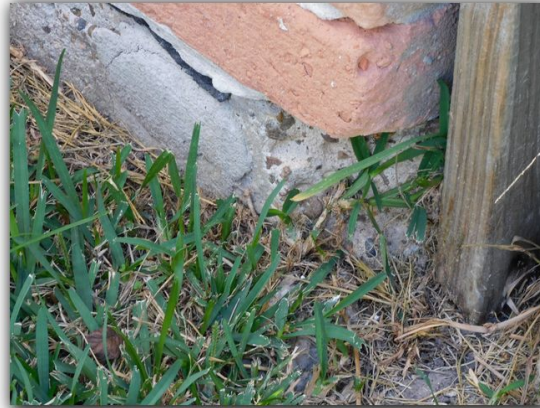
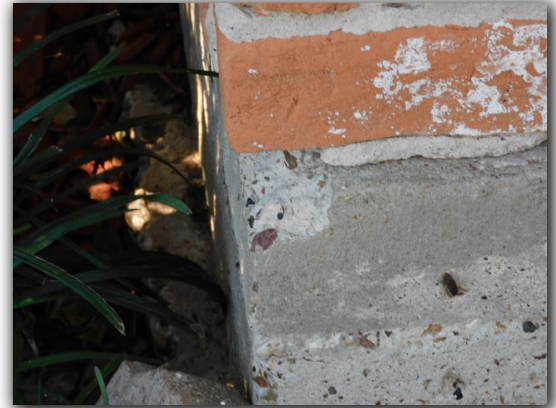
Foundation perimeter beam corners have been sheared off (corner pop).

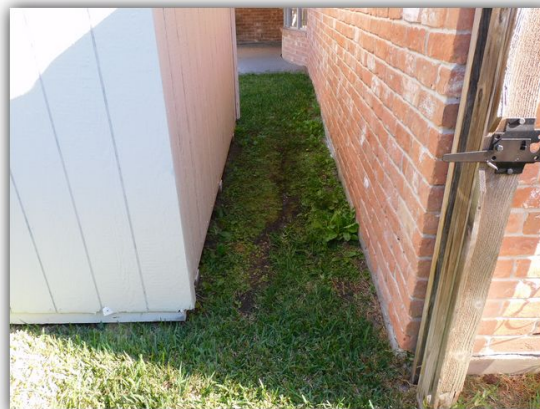
There were indications of water ponding near the foundation. Grading improvements are needed to direct run off water away from the structure to prevent water intrusion and adverse structural performance.

Grading and drainage could be improved with the installation of rain gutters to prevent erosion, water ponding and help direct water away from the foundation.

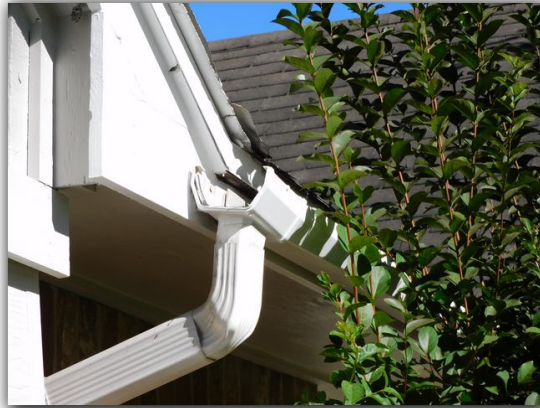
The inspector observed damaged or leaking rain gutter components that create conducive conditions for siding deterioration, soffit/eave damage, and water penetration.

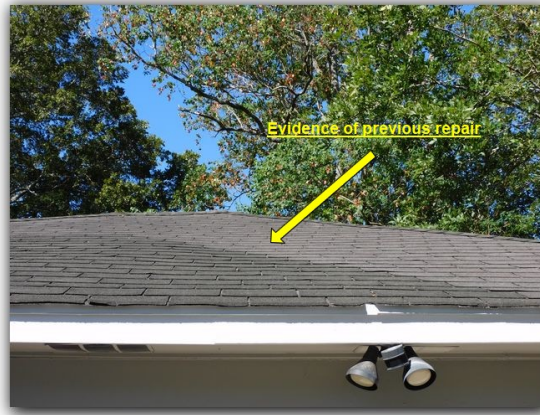
Previous repairs to the roofing covering materials and/or flashings were observed. Previous repairs should be closely monitored for defects.

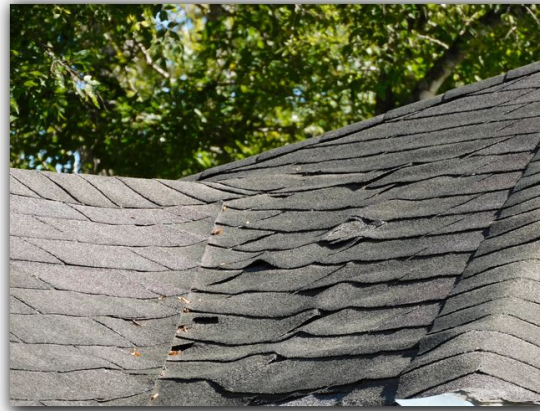
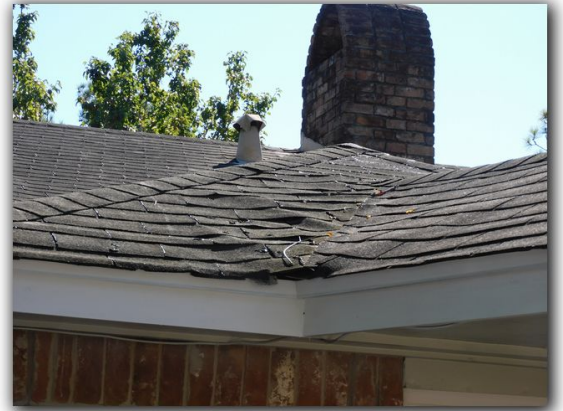
- Composition shingle tab granules were observed to be thinning on the roof covering and were an indication of age, wear or other defects.
- Discoloration of the roof covering materials was observed and was an indication of age, wear or other defects.
- Roof covering shingles that do not lay flat on the roof deck were observed.

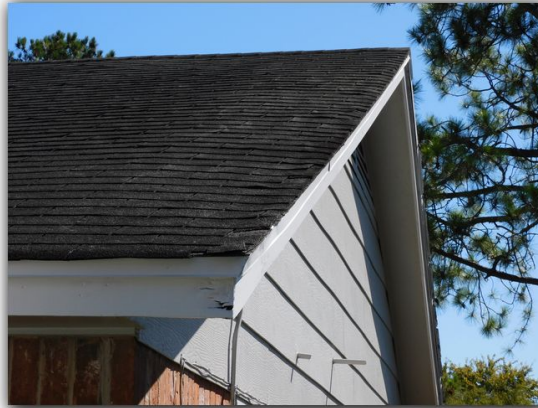
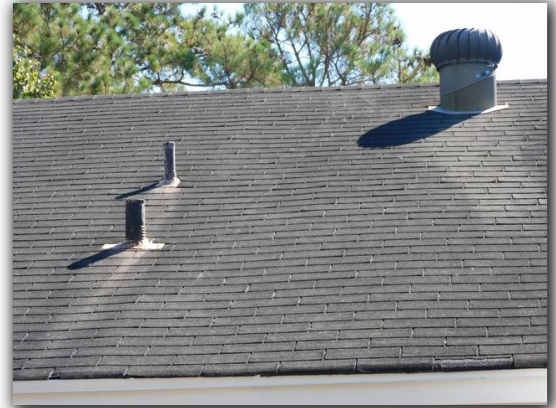
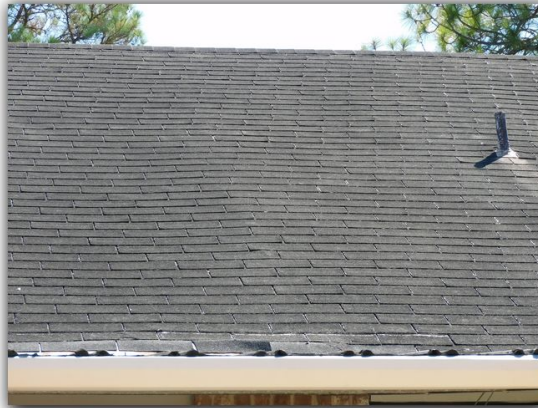
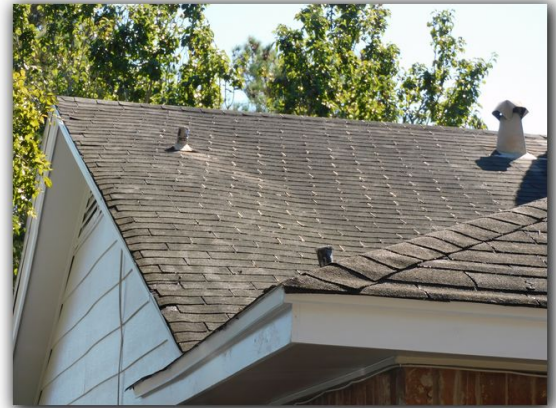
- The roof decking materials appeared to be inadequate, weak or damaged. A greater than normal flexing, sagging or deflection was observed at the roof covering.

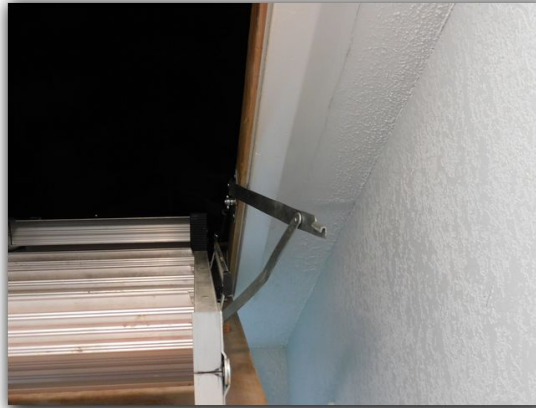
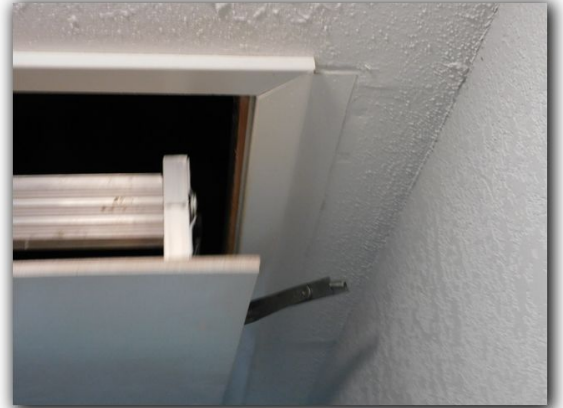
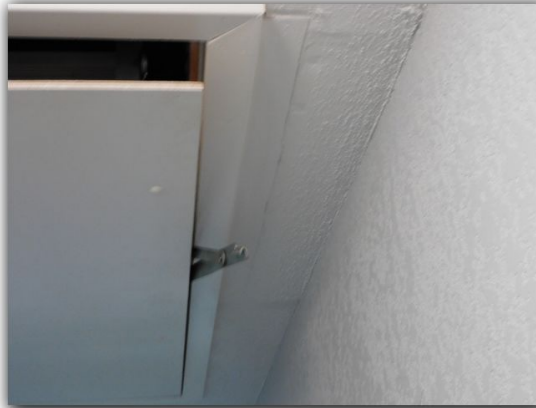
Loose, damaged or missing hardware was observed at the attic access ladder and was a **SAFETY HAZARD.**

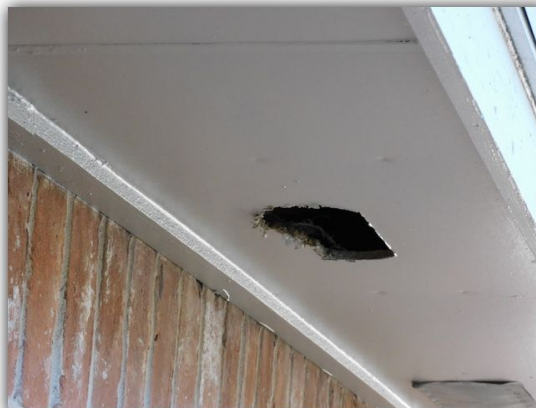
Damaged soffit vents and or vent screens were observed and may allow unwanted wildlife penetration.

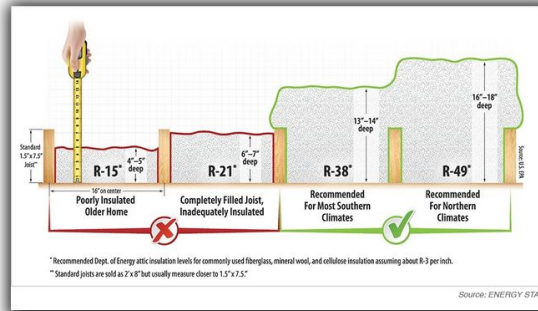
- The attic insulation was observed to be compressed, damaged or improperly installed and may not perform as intended.
- The attic insulation depth or thickness was inadequate according to current construction standards.

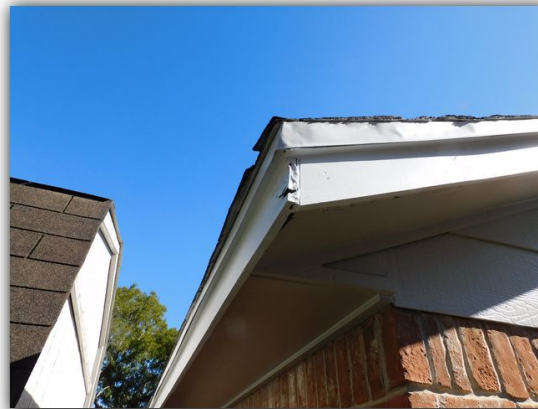
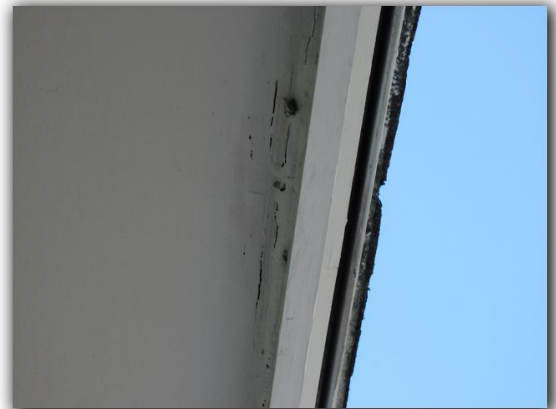
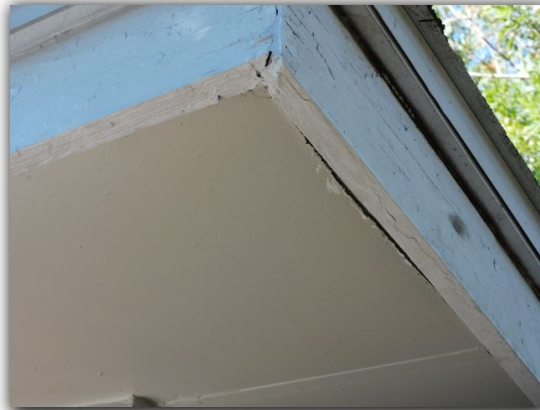
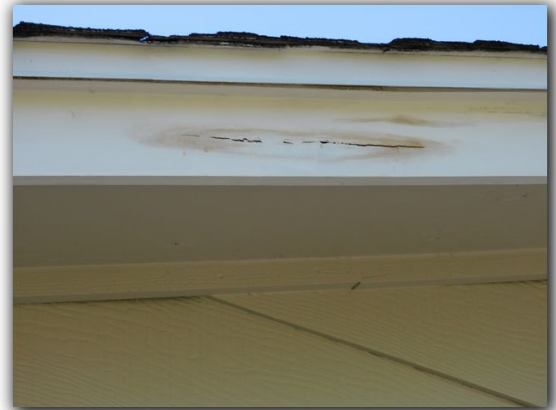
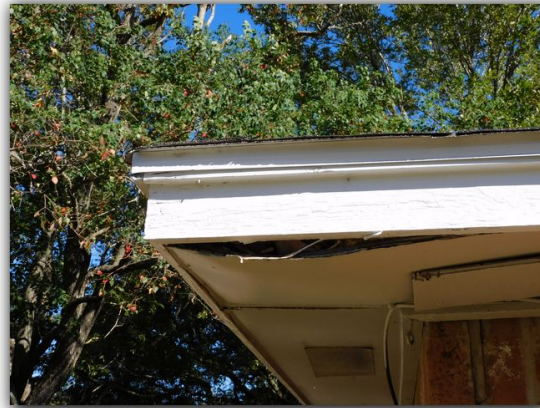
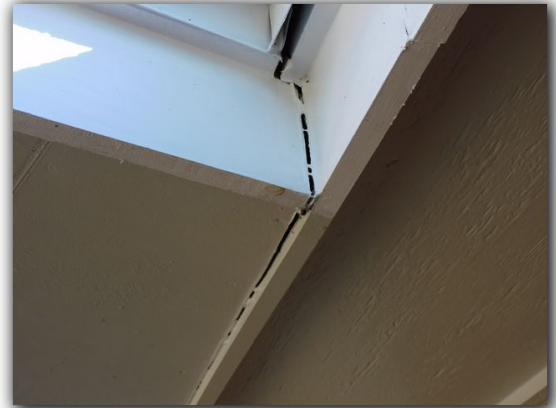
- Water stains were observed on the roof sheathing (decking).
- There were indications of moisture penetration in the attic.
- Damaged roof sheathing was observed in the attic and may not support the roof covering materials as intended and/or may allow water penetration.
- Fascia, Soffit, Frieze Board, eaves and or trim materials were observed to be damaged and should be repaired to prevent further damage, wildlife penetration and moisture penetration.

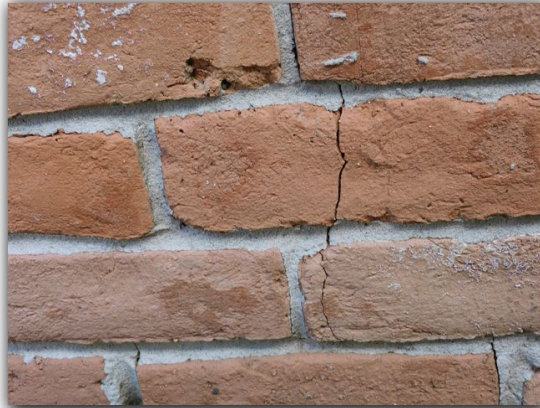
- Expansion and contraction cracks (thermal cracks, less than 1/16") in the exterior walls were observed. These cracks should be repaired to prevent further deterioration and water penetration.

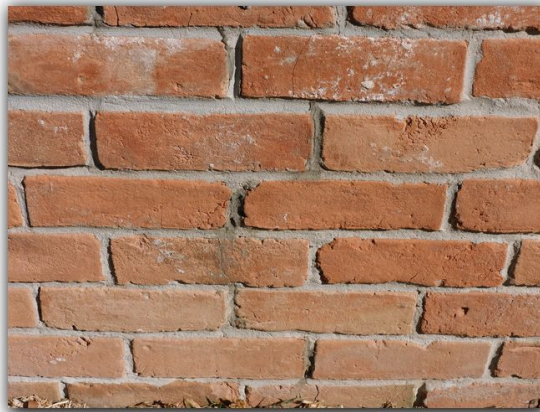
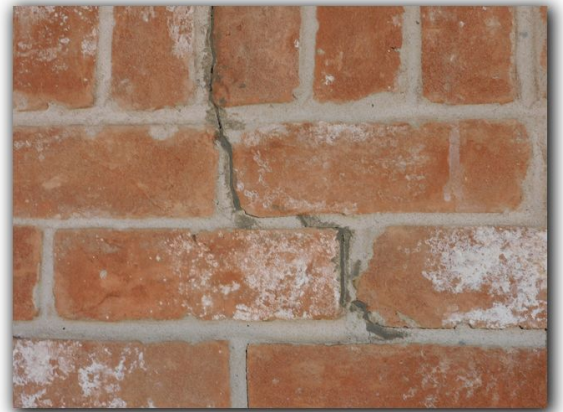
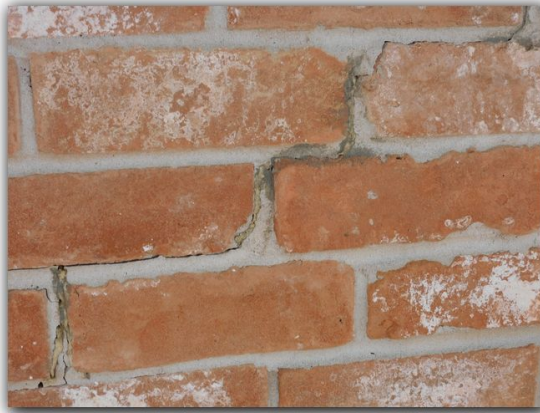
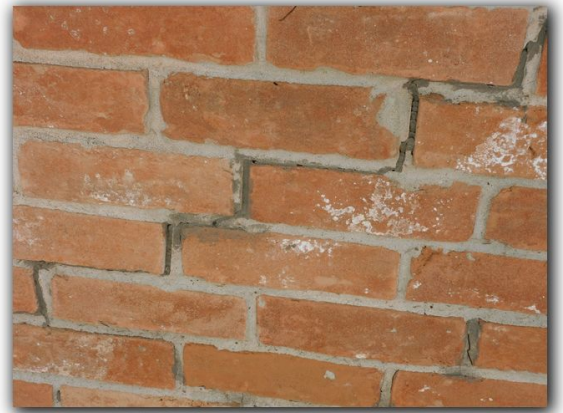
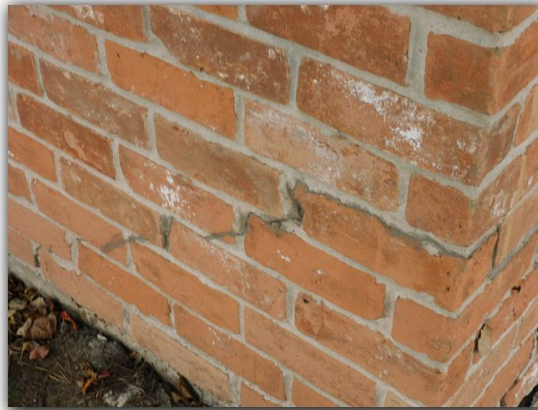
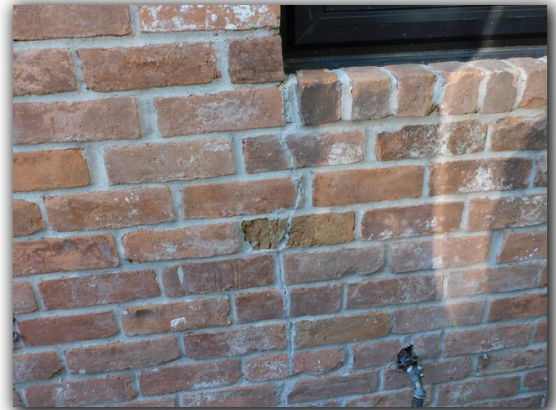
Multiple exterior wall cracks were observed to be an indication of structural settling, movement, adverse structural performance or adverse foundation performance. Further evaluation of the foundation and structure by a certified, licensed foundation and structural specialist is recommended.

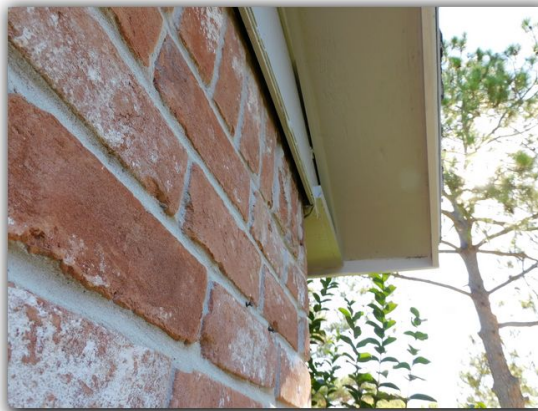
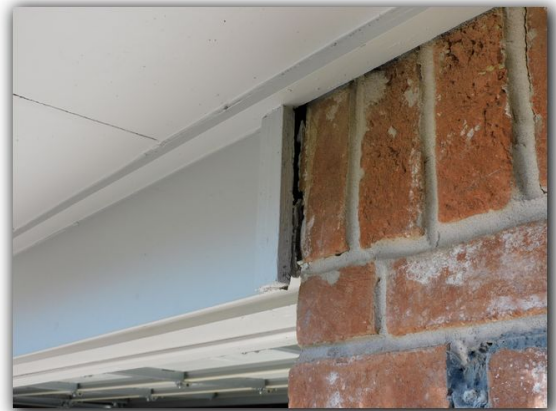
Separations at soffits, frieze boards or exterior wall cladding were observed to be an indication of movement, settlement, adverse structural performance,

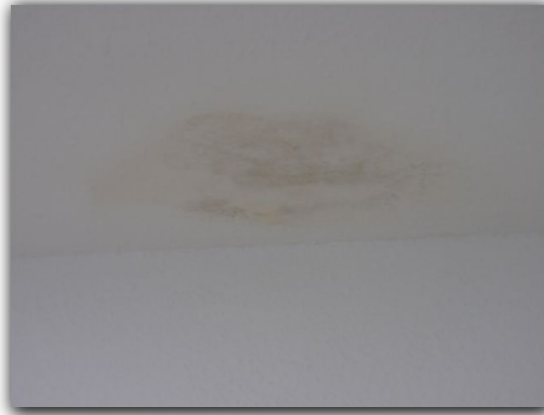
Water stains or water damage was observed at the ceiling drywall, texture and paint. The cause of the water staining or water damage should be determined and repaired as needed.

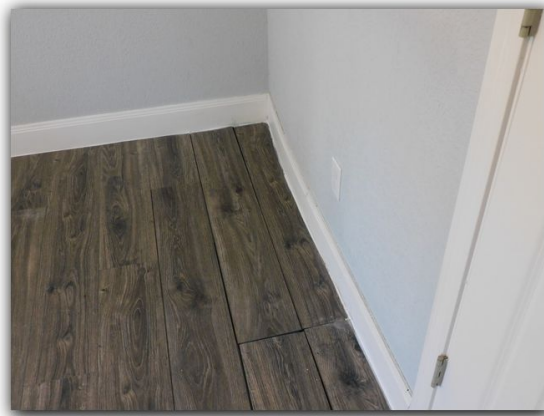
- There were cosmetic defects in the fit and finish at the interior floor covering or trim.

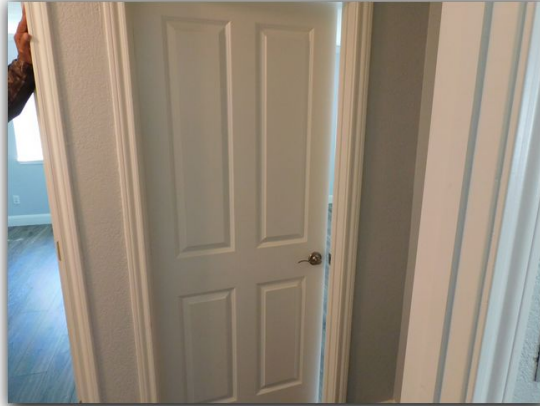
Interior doors which drift closed were observed and may be an indication of movement, settlement, adverse structural performane or other defects.

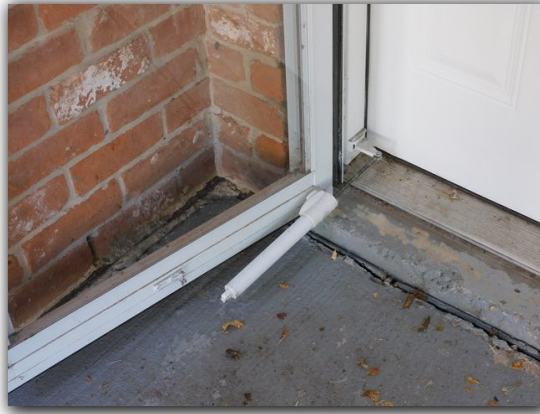
Storm doors were observed to be damaged, missing components or did not close as intended.

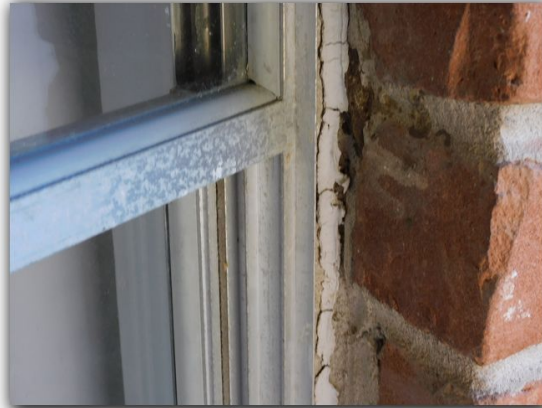
The windows need sealant between the window frames and exterior wall cladding to prevent water entrusion and the loss of conditioned air.

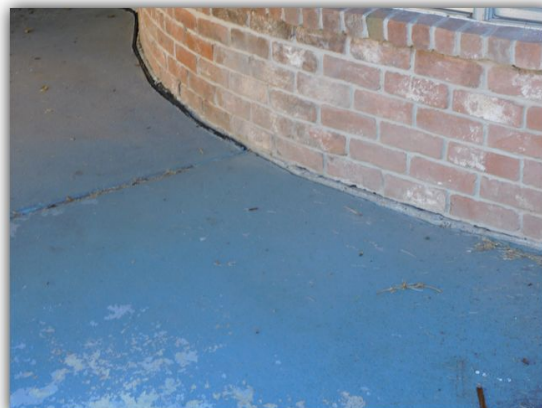
The poured concrete patio and or porch conceal the foundation or brick ledge and prevents visual inspection of the foundation in this area.

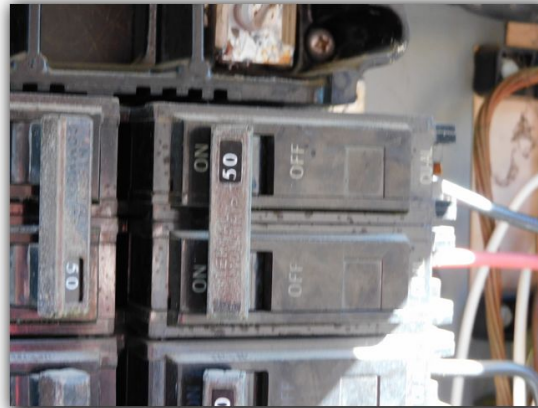
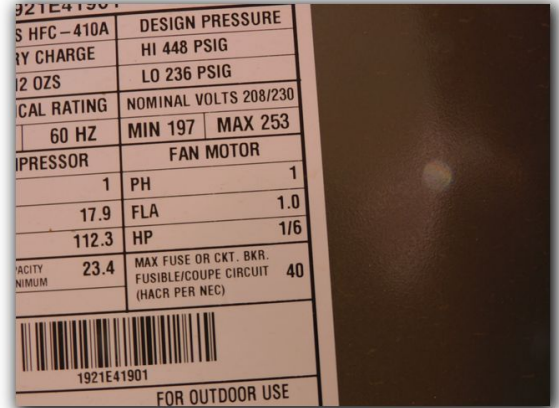
The electric service panel cabinet cover plate or dead-front screws were observed to be missing and should be replaced with the proper screws as needed.

Mismatched breaker sizes between the exterior HVAC equipment, electric disconnect and/or the electric service panel breaker were observed.

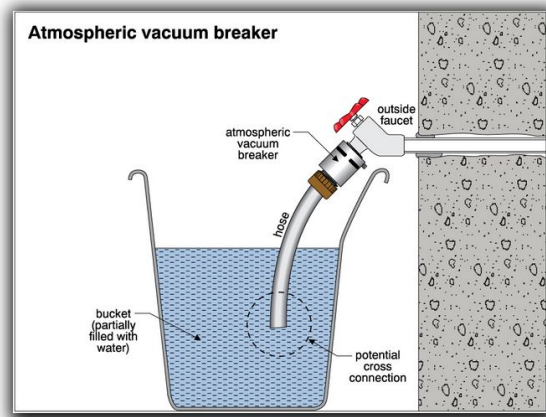
Exterior water supply faucets were missing an anti-siphon device to prevent contaminants from entering the water supply (SAFETY HAZARD).

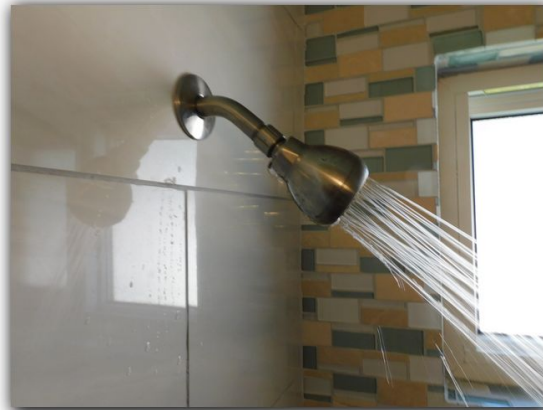
Water leaks at showerhead fixtures was observed.

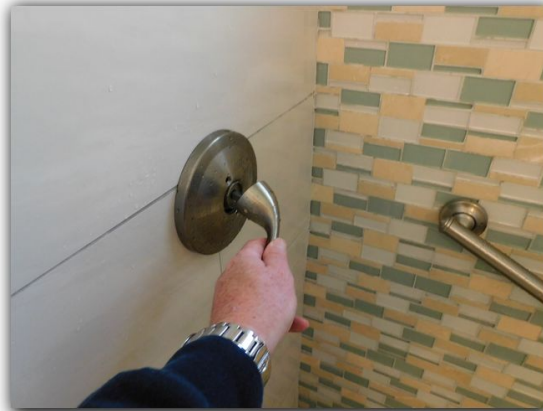
The shower water supply plumbing was loose in the wall.

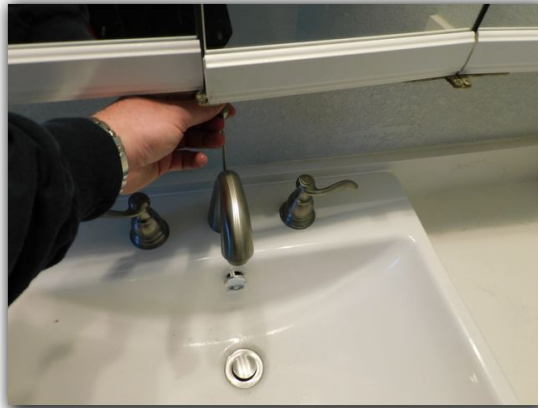
There were missing, damaged or inoperative mechanical drain stops at the sinks/tubs.

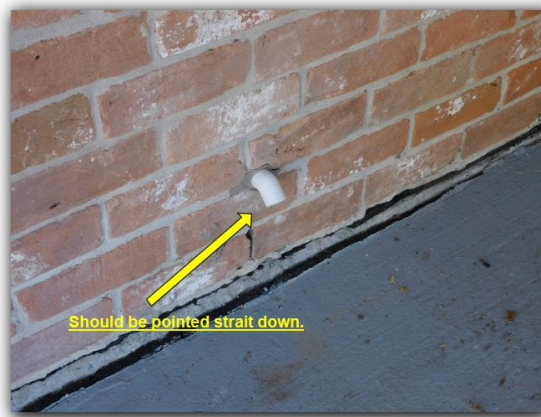
The water heating equipment TPR drain line was improperly terminated at the grade level.

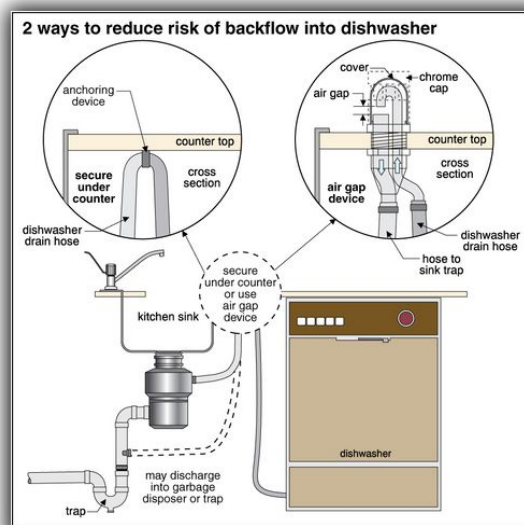
A visible anti-siphon loop or back flow prevention device was not installed at the dishwasher drain line (SAFETY HAZARD).
