HOME INSPECTION REPORT Prepared Exclusively For:

Inspected by Paul DeRick, Lic.#: 25735 on 10/23/2022 Phone: (281)744-5036, Email: derickhmins@outlook.com

PROPERTY INSPECTION REPORT FORM

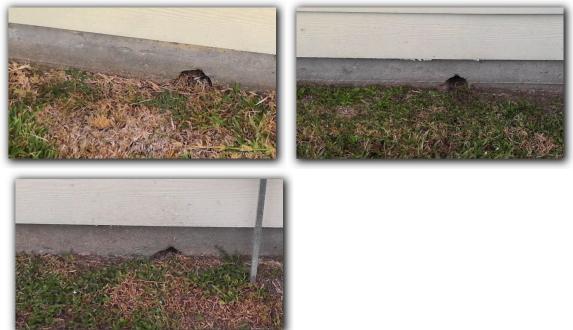
I Exposed foundation post tension cable ends were observed and may lead to adverse structural performance. Recomend a licenced Foundation contractor repair.

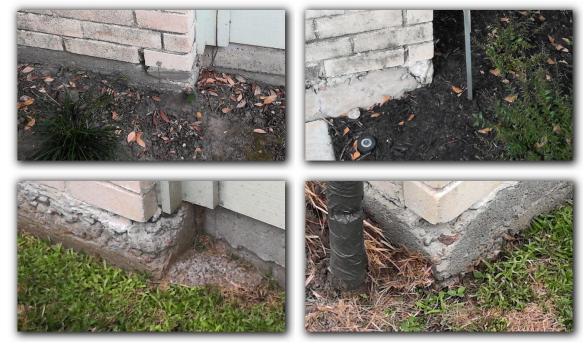
☑ Foundation perimeter beam corners have been sheared off (corner pop) multiple locations.

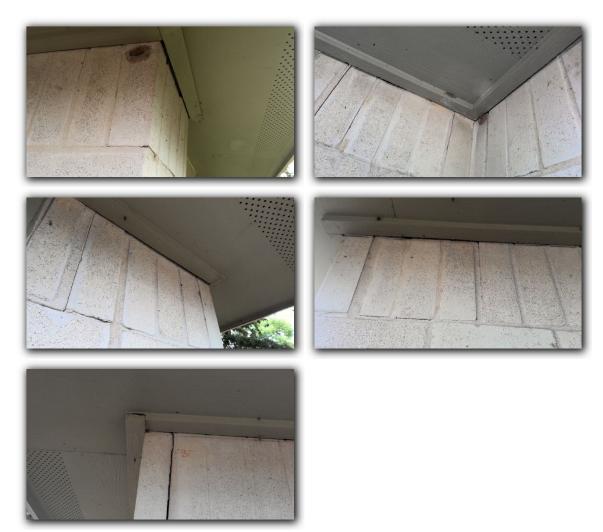
☑ Separations at soffits, frieze boards or exterior wall cladding were observed to be an indication of movement, settlement, adverse structural performance, adverse foundation performance or

other defects.
