DHI
DeRick Home Inspection

HOME INSPECTION REPORT
Prepared Exclusively For:

Inspected by Paul DeRick, Lic.#: 25735 on 10/23/2022
Phone: (281)744-5036, Email: derickhmins@outlook.com
Website: www.derickhomeinspection.com,

PROPERTY INSPECTION REPORT FORM

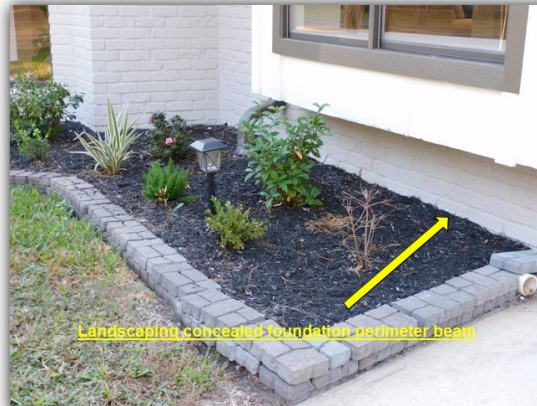
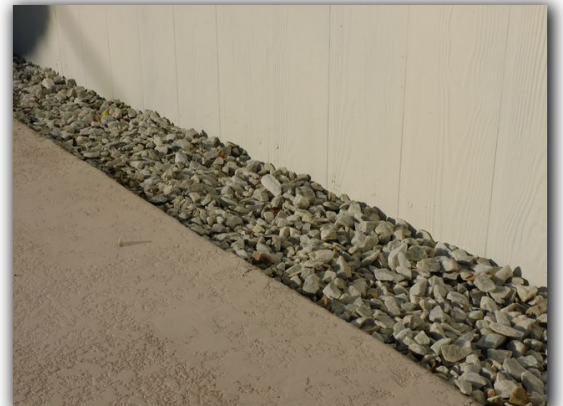
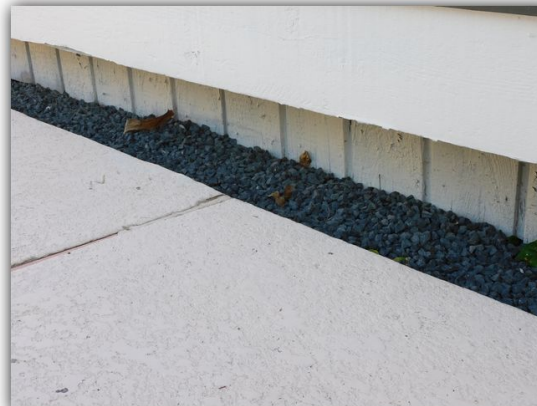
☒ **Performance Opinion:** The foundation was performing as intended at the time of the inspection and was inspected according to today's Texas Standards of Practice. **If any concerns exist about the current or future foundation performance, the inspector recommends that a foundation specialist be consulted prior to closing.**

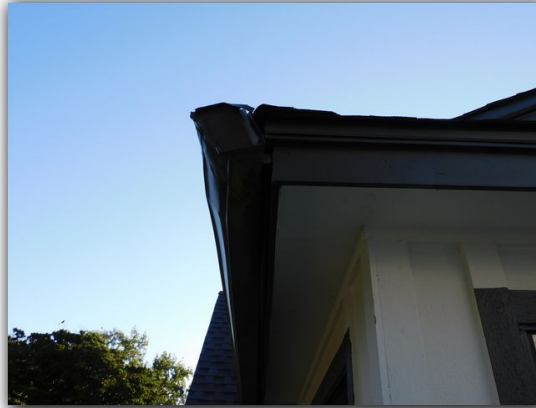
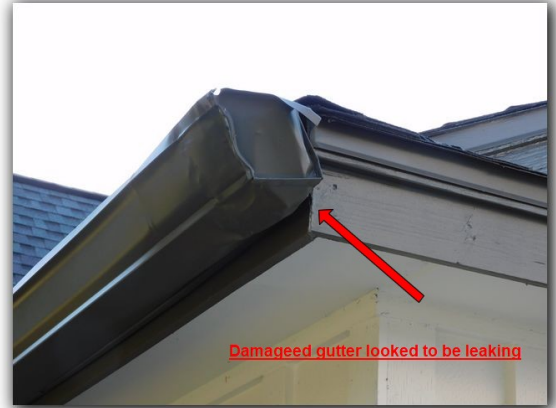
☒ The inspector observed damaged or leaking rain gutter components that create conducive conditions for siding deterioration, soffit/eave damage, and water penetration.

NOTE: Grading and drainage defects should be repaired by qualified landscape, lot drainage or rain gutter specialists.

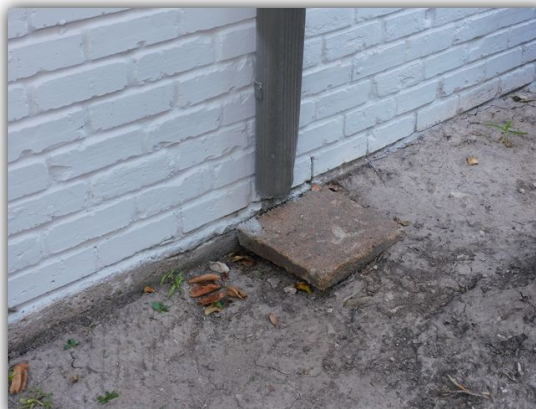
☒ All gutter downspouts should have downspout extensions or splash blocks installed to prevent water ponding and erosion.

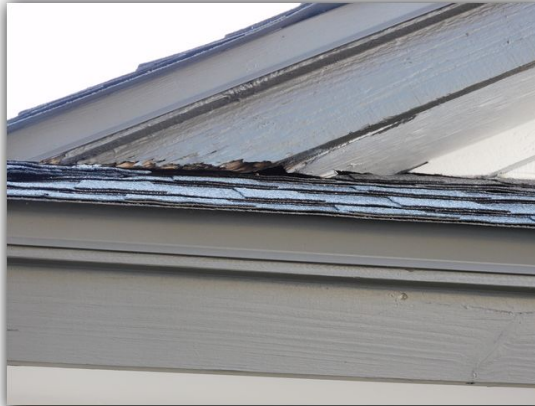
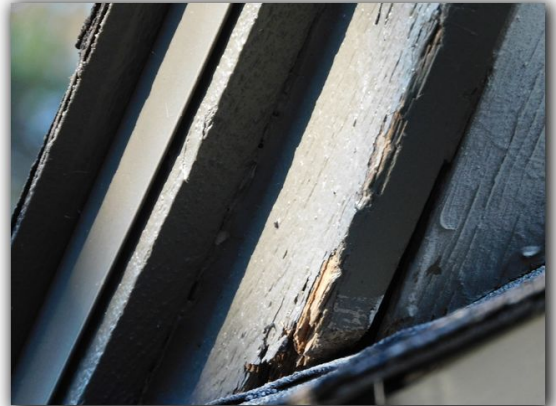
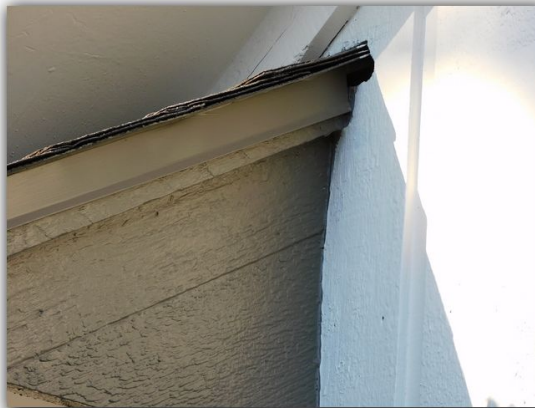
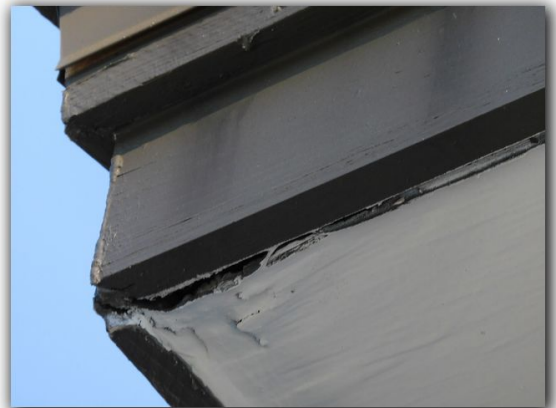
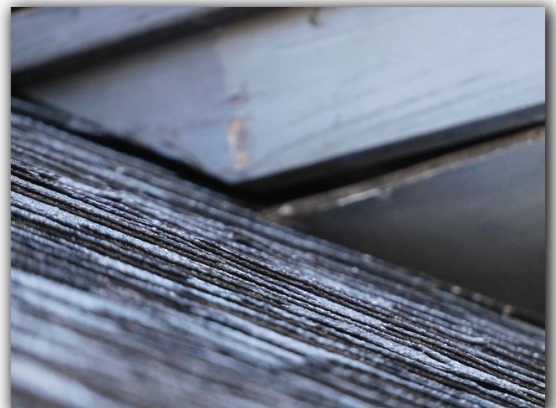
☒ Fascia, Soffit, Frieze Board, eaves and or trim materials were observed to be damaged and should be repaired to prevent further damage, wildlife penetration and moisture penetration.

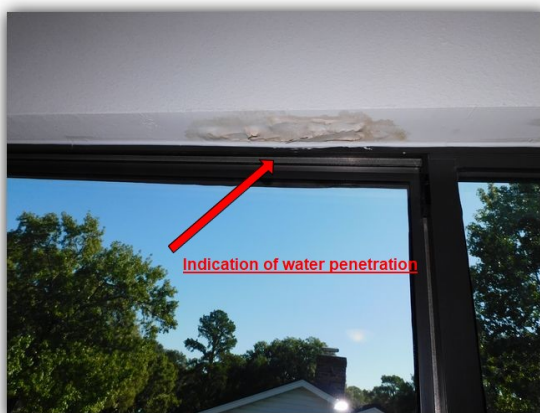
☒ Signs of water intrusion was observed at or around the windows or at the window sills.

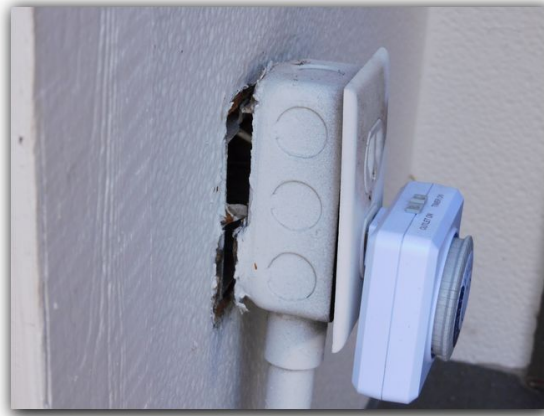
☒ Electrical Receptacle was observed to be loose the wall.

NOTE: Electric branch circuit and connected device repairs should be made by a licensed electrician.

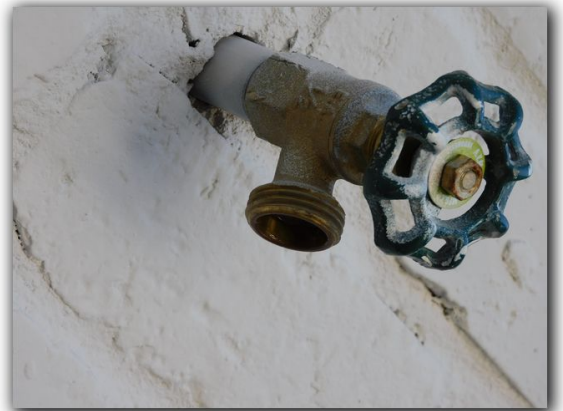
☑ Exterior water supply faucets were missing an anti-siphon device to prevent contaminants from entering the water supply (SAFETY HAZARD).
