**DHI**  
**DeRick Home Inspection**

HOME INSPECTION REPORT  
**Prepared Exclusively For:**

Inspected by Paul DeRick, Lic.#: 25735 on 10/23/2022  
Phone: (281)744-5036, Email: [derickhmins@outlook.com](mailto:derickhmins@outlook.com)  
Website: [www.derickhomeinspection.com](http://www.derickhomeinspection.com),

# PROPERTY INSPECTION REPORT FORM

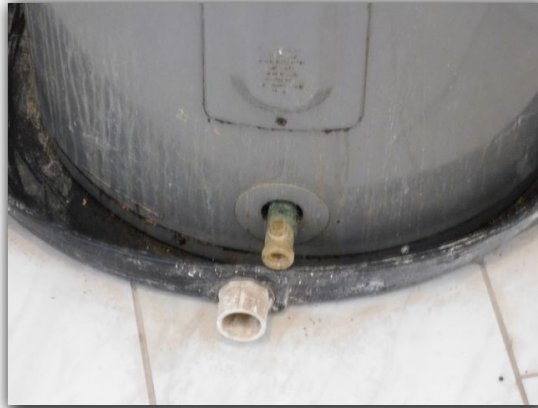
The water heating equipment TPR valve was inspected and verified, but was not tested. It is common for TPR Drain valves to fail under testing and leak water.

The water heating equipment TPR drain line was improperly terminated at the grade level.
